Erosion and Accretion Trends Along the Lake Michigan Shore at North Point Marina and Illinois Beach State Park

**Year-3 (1997) Report of a Four-Year Study of Coastal Geology
and Coastal Geologic Processes**

**Anthony M. Foyle
Michael J. Chrzastowski
and
C. Brian Trask**

March 1998

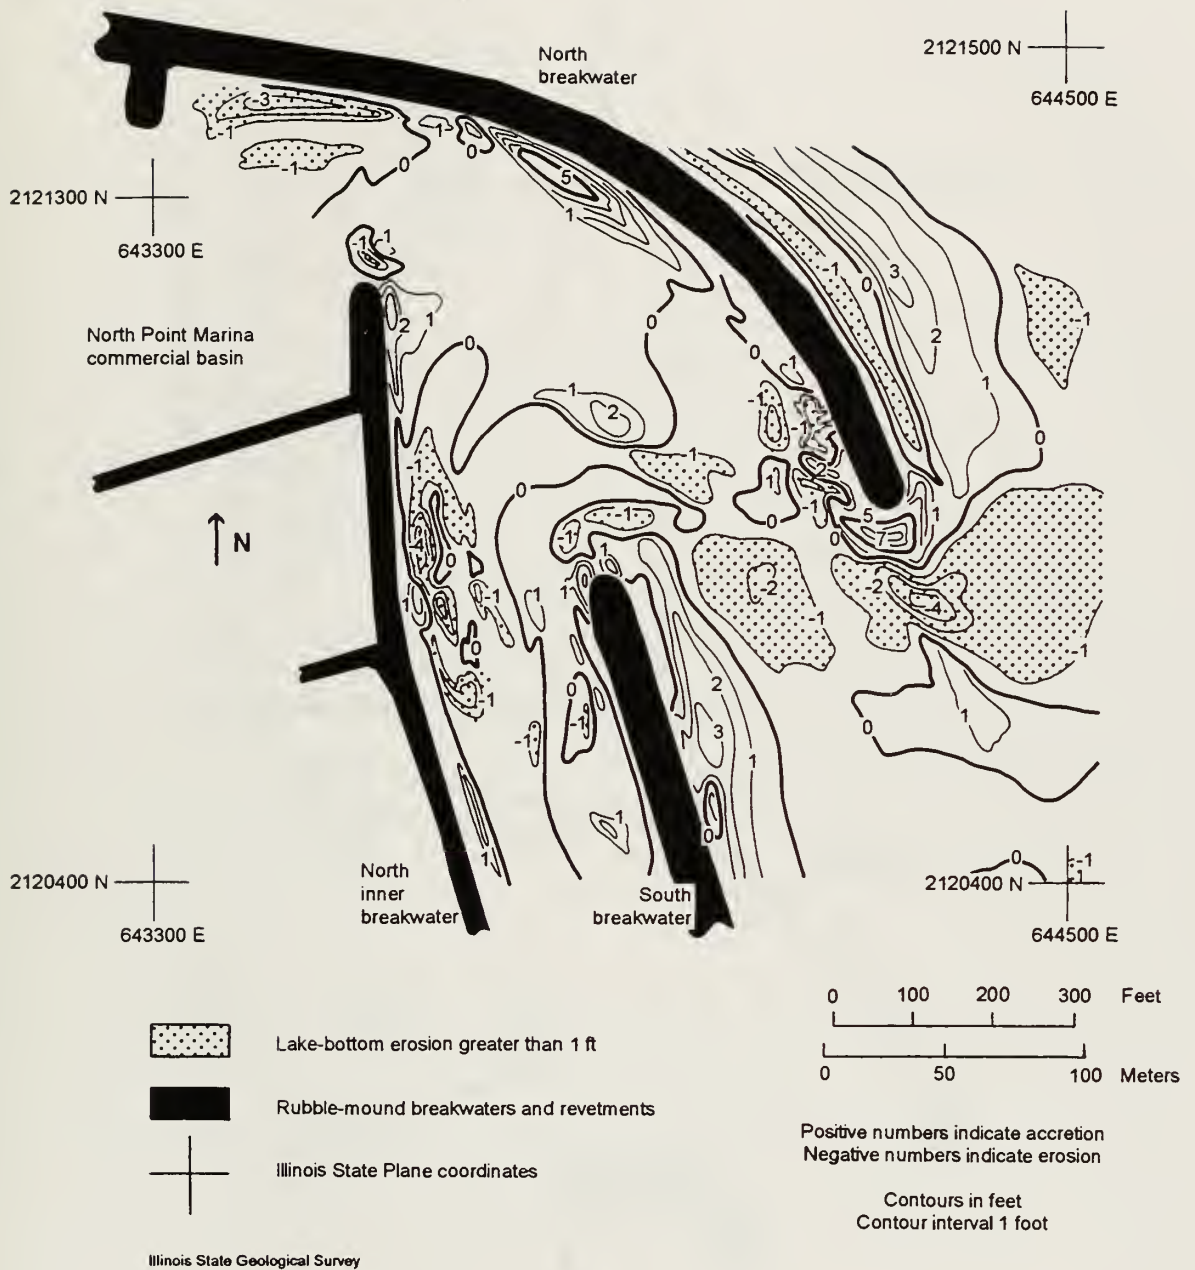
Figure 3-10 1996-1997 lake-bottom change in the North Point Marina entrance and in the approaches to the recreational boat basin. Lake-bottom change in the marina entrance was partly affected by dredging in summer 1996 immediately following collection of 1996 bathymetric data.

Erosion Erosion in excess of 1 ft occurred primarily just east of the spur on the north breakwater, and just north of the tip of the north inner breakwater (Fig. 3-10); there was just over 3 ft of erosion in both areas. Small localized patches of erosion occurred near the tip of the north breakwater where the lake bottom deepened by up to 3 ft. Erosion in this area was part of a larger erosional band that extended into the entrance from offshore (Figs. 3-4, 3-10).

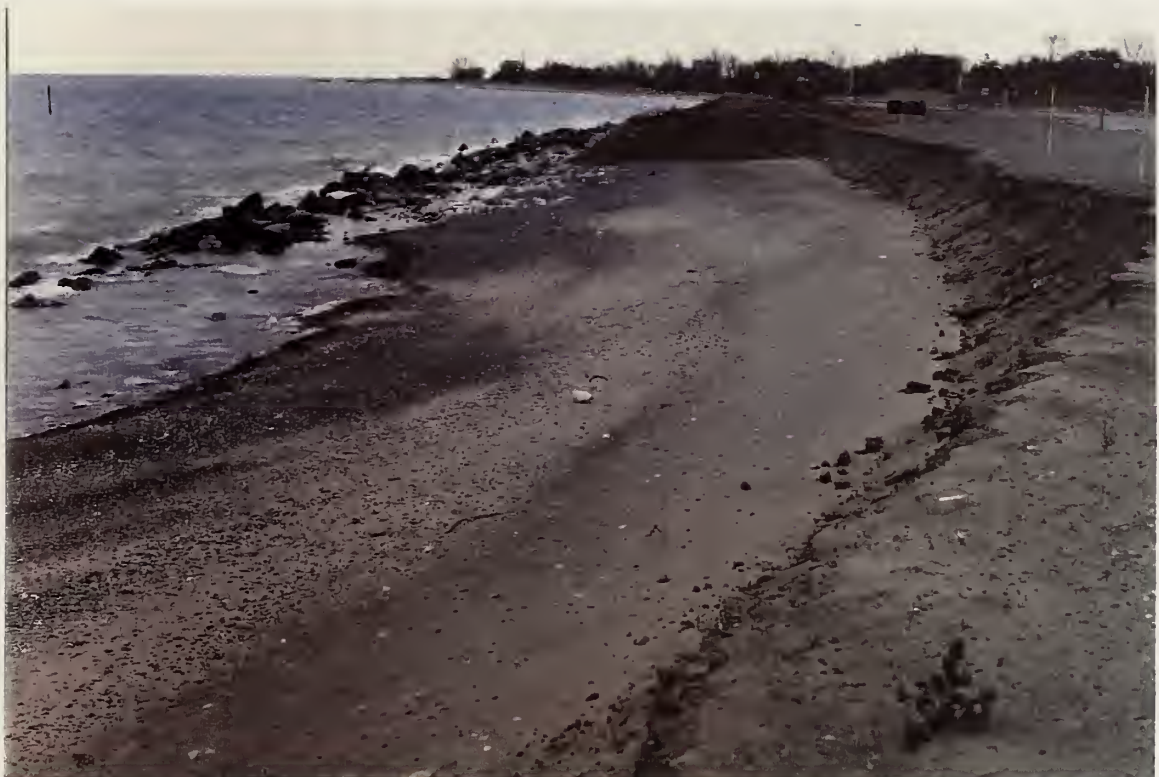
Figure 3-13 Photograph showing the riprap-defended shoreline and erosion of the sand and gravel backfill along the NPM south parking area. Photograph shows ground conditions in the early phase of construction of the shoreline revetment (November 1997; see text). The scarp height ranges from 6 to 7 ft, and as much as 70 ft of scarp recession has occurred since April 1997 when the scarp lay near the line of riprap (left side of photo). The sand and riprap addition associated with construction of the shoreline revetment can be seen in the background. View is to the south from a point due east of the southernmost keyed-access parking lot gate. The Camp Logan headland is visible in the distance (Photo date: November 13, 1997).

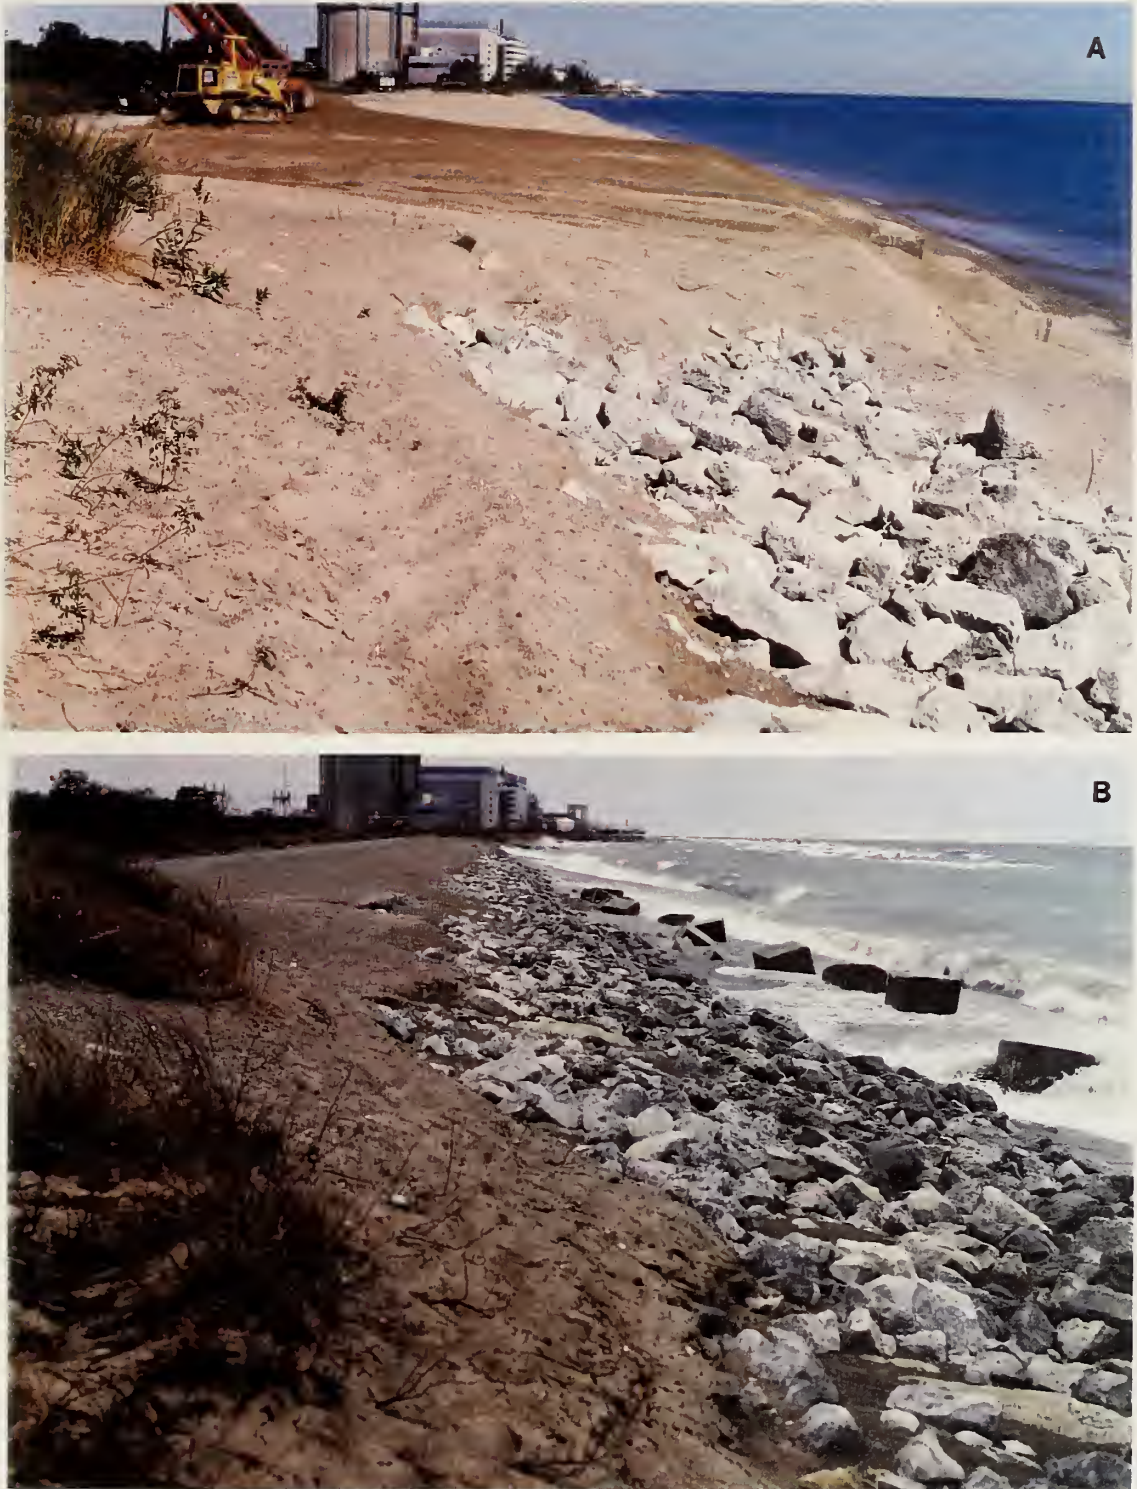
Figure 3-16 Photographs showing the IBSP/SU beach-nourishment stockpile. Photographs show stockpile geometry: (A) just prior to completion of 1997 nourishment; and (B) eight weeks following nourishment. View is to the north. Note that concrete cubes and riprap are re-exposed in (B) due to erosion of nourishment material (photo dates: September 17, 1997 (A), and November 14, 1997 (B)).

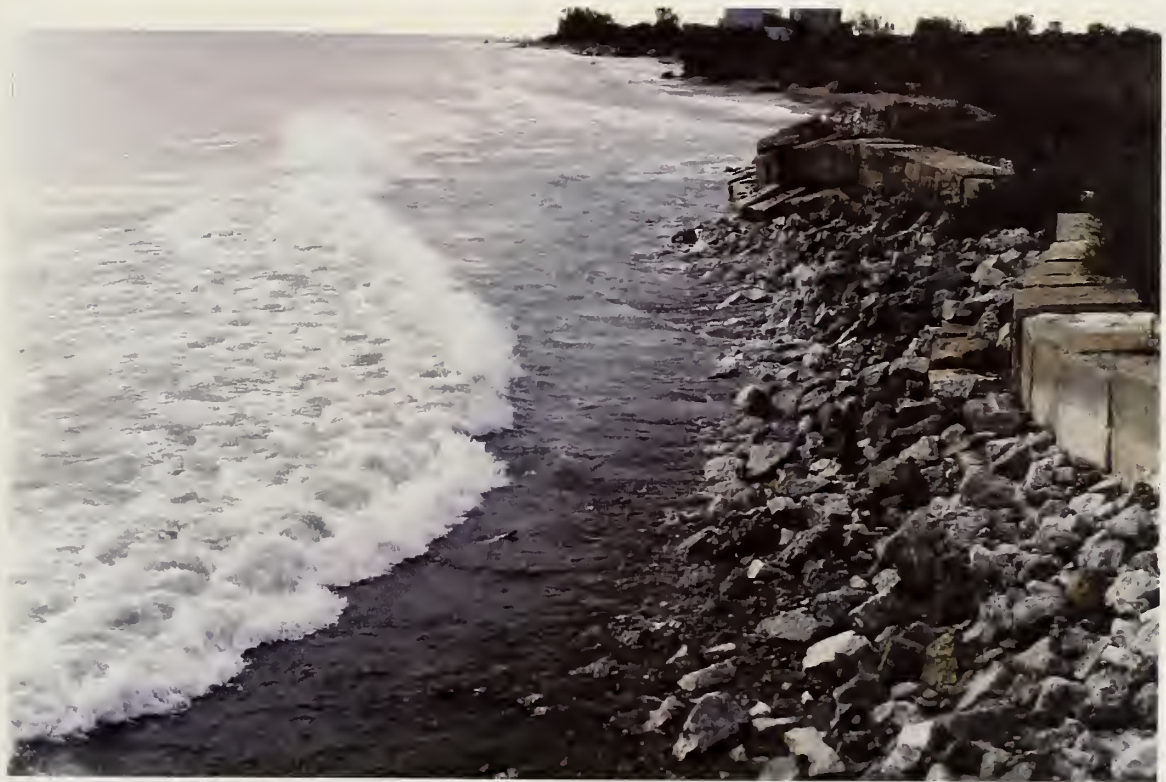
Figure 3-18 Shoreline recession in IBSP/NU. As of autumn 1997, the 2400-ft shoreline in this photo had retreated 25 ft (foreground) to 75 ft (background) landward of its summer 1996 position. Shoreline recession was accompanied by a decrease in beach area of 1.75 acres. View is to the south from the concrete-cube and riprap-protected headland at the Zion-Benton pump house on 17th Street (just south of North Point Sailing Beach; Fig. 3-19). For scale, the concrete cubes in the foreground measure 3 ft by 4 ft by 4 ft (photo date: October 22, 1997).

- (2) The greatest amount of recession within the coastal reach (up to 140 ft) occurred at North Point Sailing Beach in IBSP/NU. Shoreline recession caused the loss of 1.7 acres of beach along this 1400 ft of shore. Riprap and concrete-cube shore defenses on the backshore prevented erosion of areas landward of the beach.

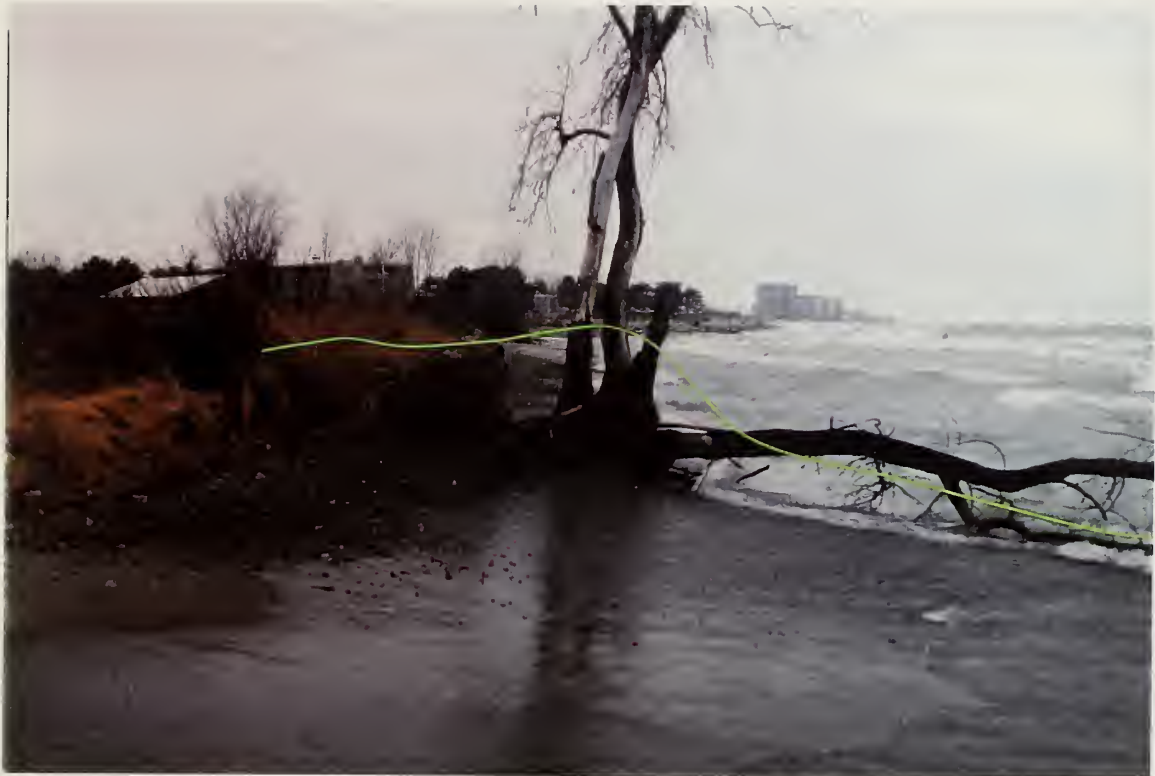
Figure 3-20 1997 shoreline recession and erosion of a relict beach ridge in IBSP/SU. The relict beach ridge is capped by dune sands at this locality. During summer 1996, the shoreline was located just to the right of the field of view. Green line shows approximate ridge outline and beach surface during summer 1996. View is to the north. The south end of the stone riprap and steel sheetpile bulkhead at the IBSP Lodge is visible in the distance (photo date: November 14, 1997).

At the erosion hotspots shown in Fig. 3-19, erosion of relict beach ridges and their capping modern-dune sands generally occurred along stretches of natural beach that were initially relatively narrow. Figure 3-22 shows examples of significant beach loss and (or) erosion of relict beach-ridge and dune sands that occurred at two sites (Range Lines 4B and 4C) located between the IBSP Lodge and Dead River. These cross-sectional profiles illustrate that shoreline recession accompanying 1996-1997 lake-level rise caused beach narrowing and was generally accompanied by erosion in the shallow nearshore. Beach narrowing exposed the relict beach ridge to wave runup and attack in areas where the preexisting beach was already narrow. This was the case at Range Line 4B where erosion of the beach ridge occurred in an area where the preexisting beach was only about 25 ft wide. At Range Line 4C, the preexisting beach was sufficiently wide (at least 60 ft) that shoreline recession did not expose the relict beach ridge and capping dune sands to wave attack.

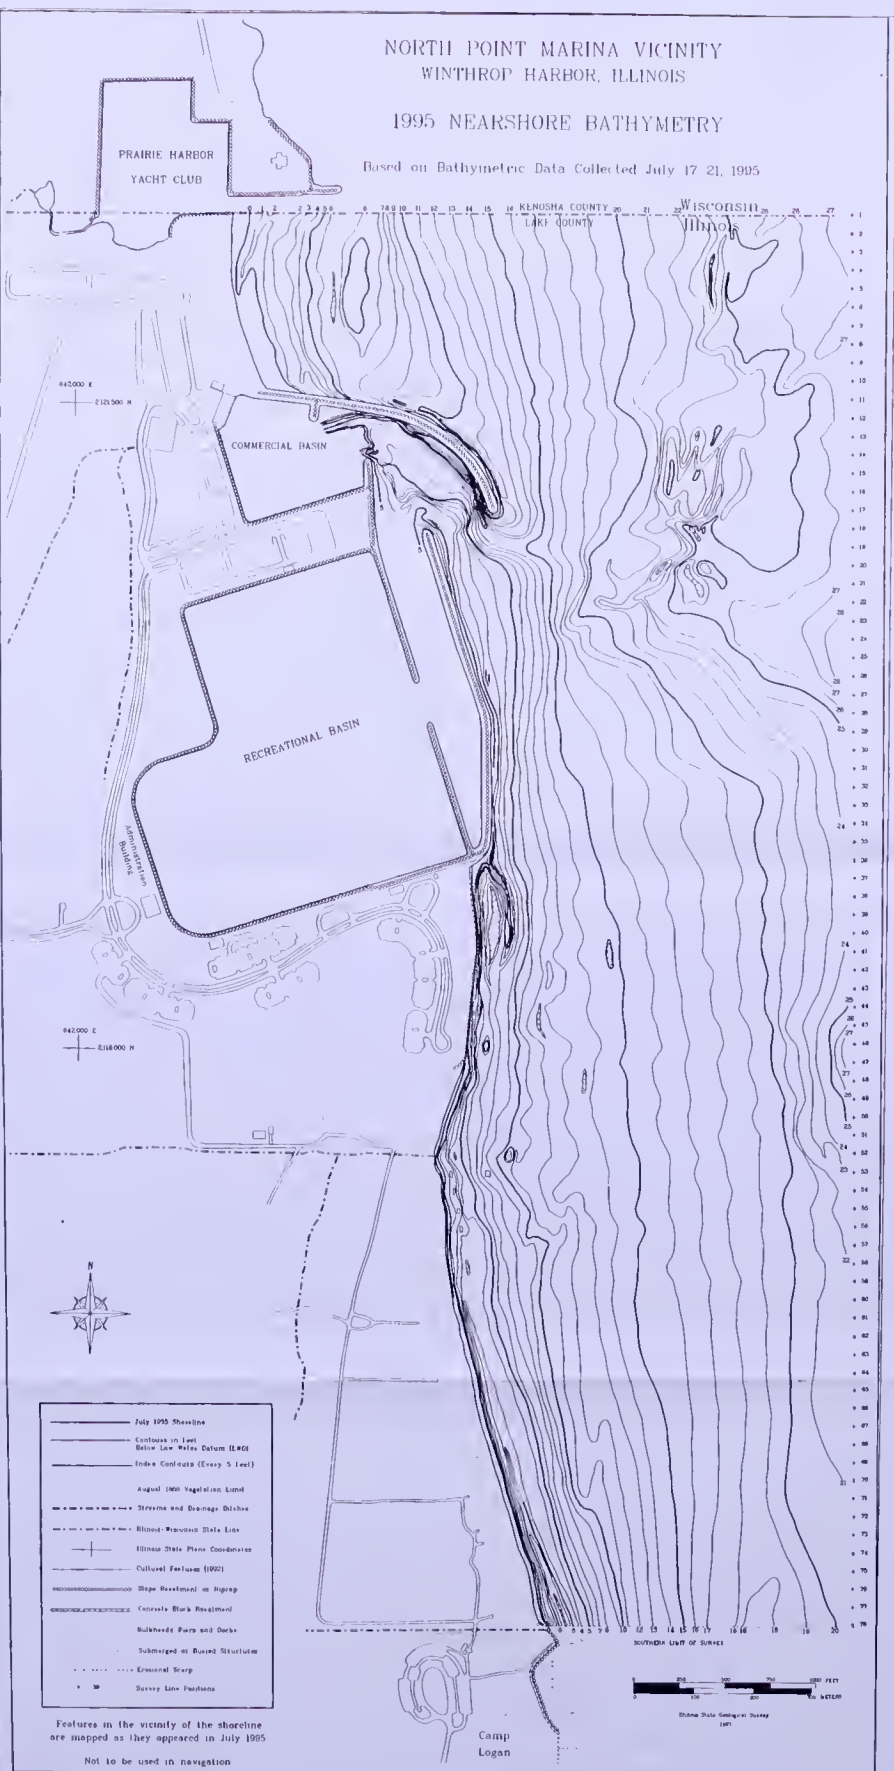
1995 NEARSHORE BATHYMETRY

Based on Bathymetric Data Collected July 17 21, 1995

Features in the vicinity of the shoreline
are mapped as they appeared in July 1995
Not to be used in navigation
